Restoration of damp masonry

Consolidation and reinforcement of masonry

Renovation of plaster

Adaptation to fire regulations

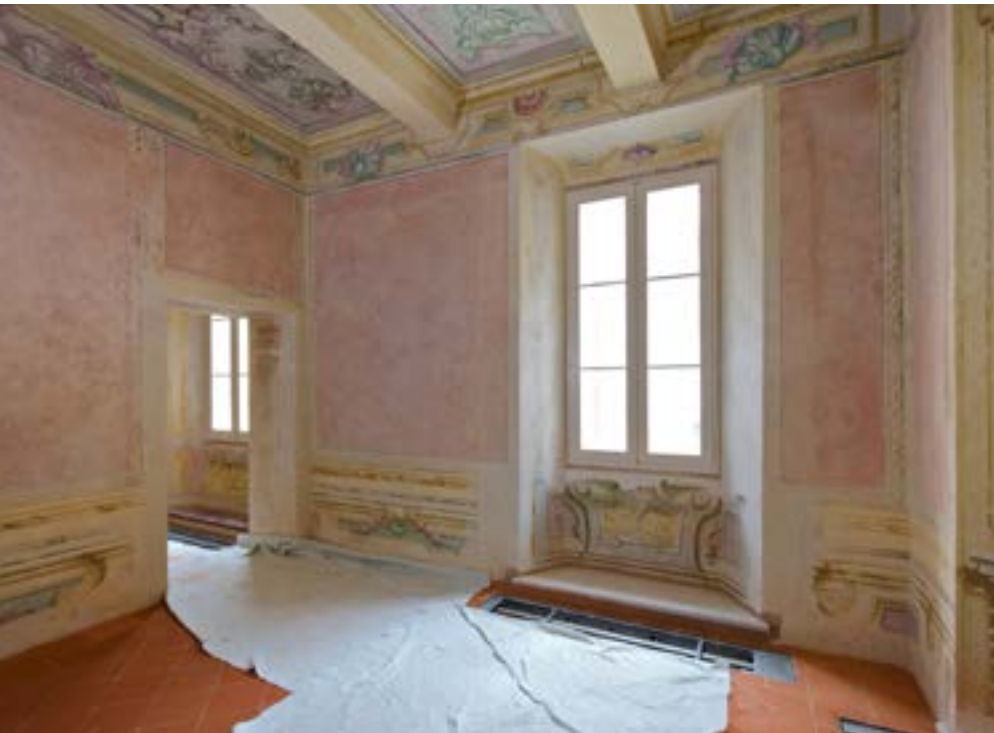
Restoration of wall decorations

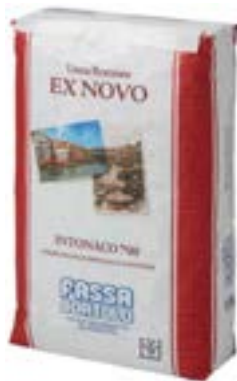
INTONACO 700
Bio base coat plaster made from NHL 3.5 natural hydraulic lime for interiors and exteriors

- total removal of the existing plaster
- application of a first layer of **RINZAFFO 720**
- once the undercoat had dried, application of **INTO-NACO 700**, bio base coat plaster made from NHL 3.5 natural hydraulic lime
- completion of the cycle by applying **FINITURA 750** bio plaster with marmorino finish

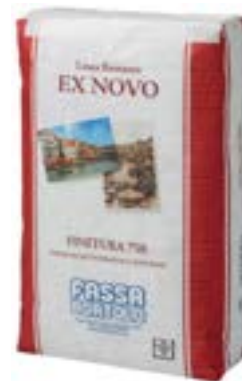
FINITURA 750
Bio finish coat plaster made from NHL 3.5 natural hydraulic lime for the restoration of damp masonry, with marmorino effect, for interiors and exteriors

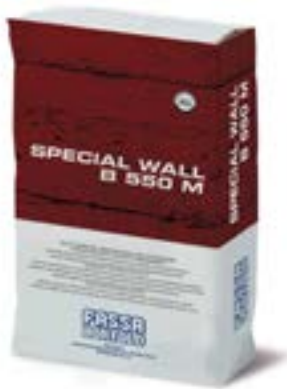
SPECIAL WALL B 550 M

Fibre-reinforced one-component mortar with controlled shrinkage, sulphate-resistant, for repairing and reinforcing mixed masonry, walls in historic buildings and filling

The load-bearing capacity of the supporting walls was reinforced using **SPECIAL WALL B 550 M**, a fibre-reinforced, one-component, sulphate-resistant mortar with controlled shrinkage, specifically for repairing and reinforcing mixed masonry or historic walls and filling.

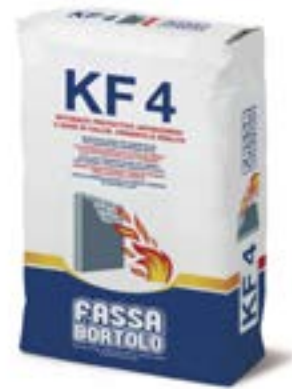
KF 4

Fire protection plaster made from lime, cement and perlite, for interiors and exteriors

Finally, to ensure compliance with fire regulations the rooms housing the central heating system, **KF 4** fire-resistant protective plaster made from lime, cement and perlite was used.
