HISTORICAL RESTORATION AND CONSOLIDATION

FASSA BORTOLO SYSTEMS AND PRODUCTS

TYPE OF WORK

Renovation and restoration
of façades and hallway

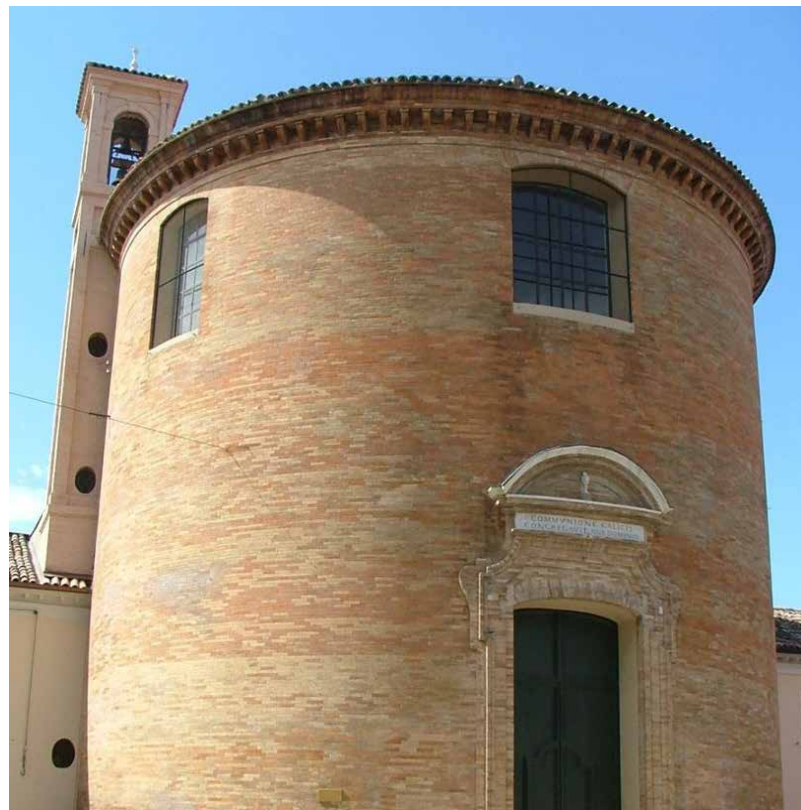
View from the outside

The structure, with a circular floor plan, has a diameter of around 13 metres and features beautiful eighteenth-century lines and facing bricks on the exterior shell.
